Case study 1.0

## FRANCESTLE CONFECTIONERIES, Flooring Solution

# Solution Implemented

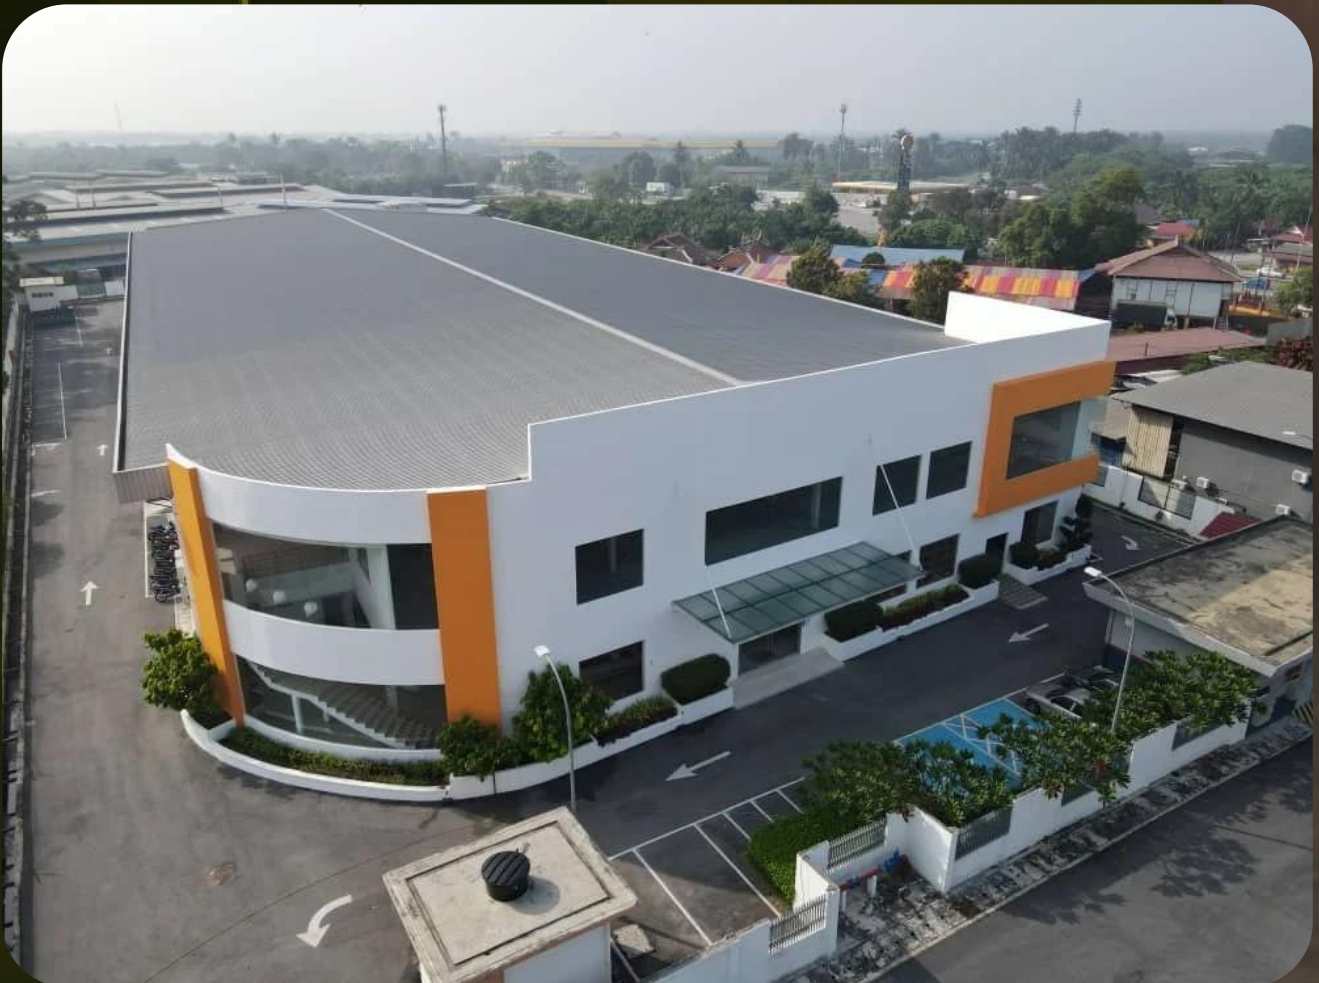
Franscastle Confectionery established a new production plant in a damp industrial area. Despite installing a damp-proof membrane during construction, subsequent inspection revealed inconsistent moisture levels across the slab, raising the suspicion of rising ground moisture.

Flooring solution required for 3,000 sqm of porous substrate in their production and warehouse area, which must withstand high traffic, heavy machinery, and strict hygiene standards inherent to foods manufacturing

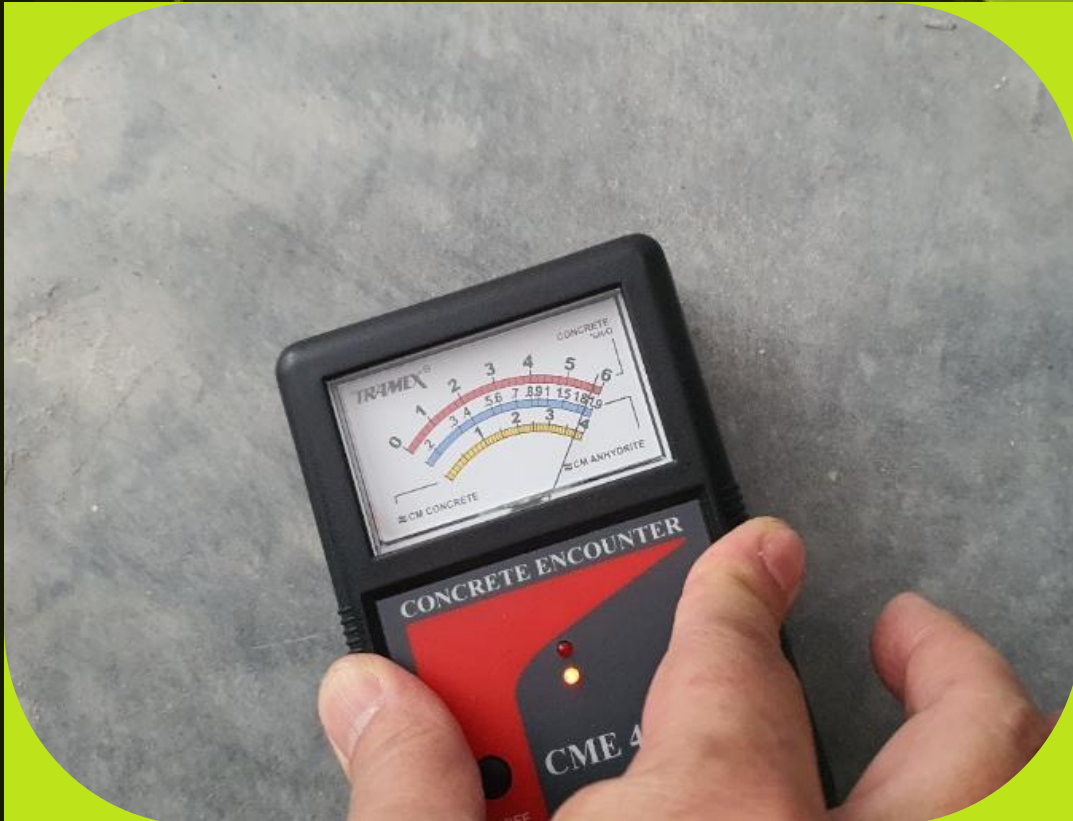
## The Moisture Challenge

Moisture in concrete is one of the most underestimated threats to resin flooring. Without proper treatment, excessive moisture can:

- Cause osmotic blistering and delamination of PU systems.
- Accelerate adhesion failure, especially under thermal and traffic stress.
- Trap microbial growth beneath the floor, creating hygiene concerns.
- Lead to premature floor failure, resulting in downtime and costly repairs.

It is often misunderstood that polyurethane flooring can withstand rising damp without special treatment. While PU-MF is highly durable against mechanical and chemical attack, it is still vulnerable if substrate moisture is uncontrolled. Therefore, a moisture management strategy was non-negotiable.

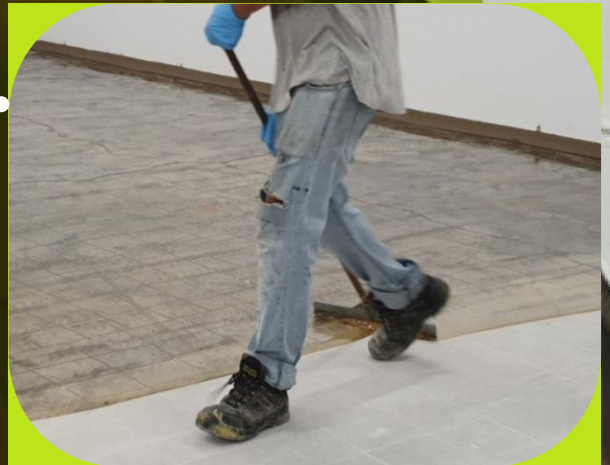
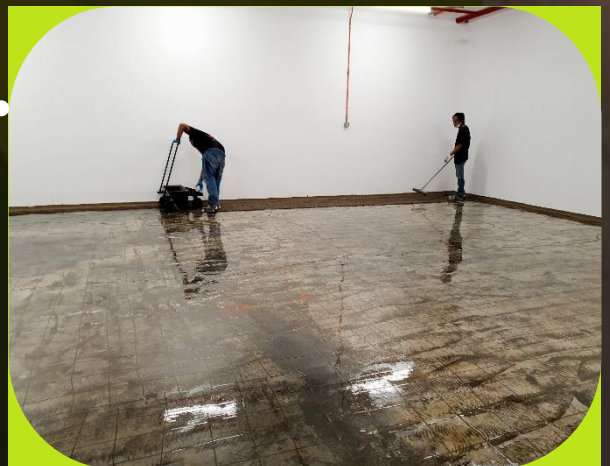
1.

Chosen right primer as the bonding bridge between substrate and epoxy mortar.

Deep penetration sealed surface porosity and consolidated weak areas.

Solvent-free to prevent blistering and ensure low VOC for food environments.

Provided a tacky surface with extended open time, enabling mortar to be applied wet-to-wet for a strong chemical bond.

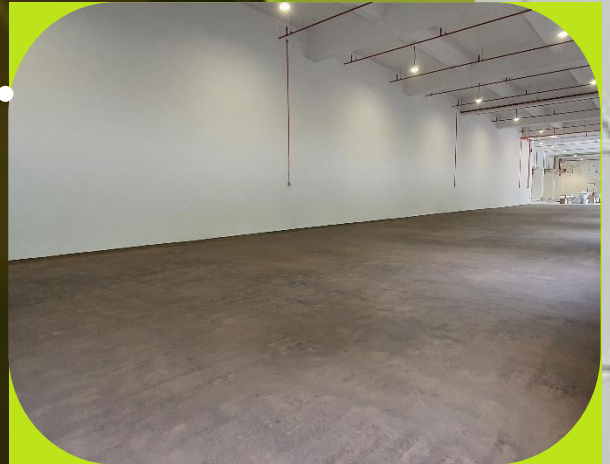
### 3.

Applied PORE SEALER to close residual porosity in the mortar. Prepared the surface for the PU-MF topcoat.

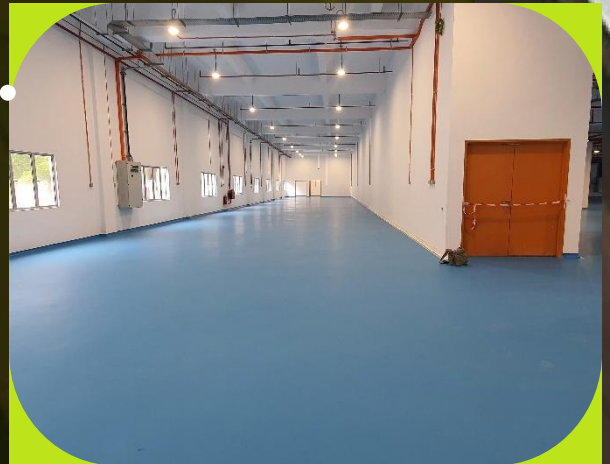
### 4.

Selected **FLOORCRETE PU-MF** for its outstanding suitability in food production areas: Seamless & hygienic, preventing bacterial growth. Excellent chemical resistance to sugars, oils, and cleaning agents. Thermal shock resistance to withstand hot water cleaning. High durability under traffic, impact, and abrasion.

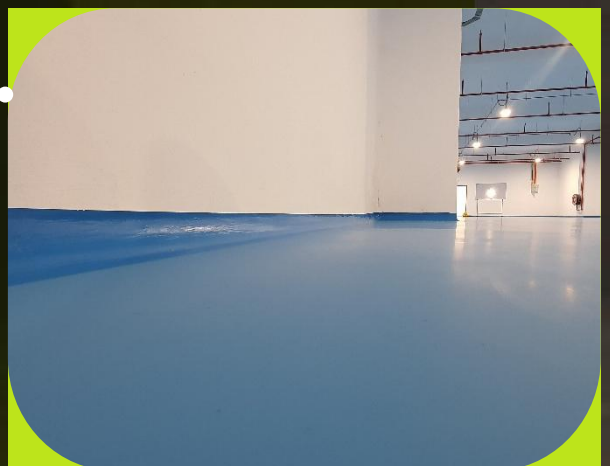
### 5.

#### Coving & Wall Treatment

During coving installation, the wall plastering was found to be weak and prone to delamination. To minimize stress on the fragile plaster, a water-based epoxy coating was applied, ensuring both adhesion and long-term durability without damaging the substrate.

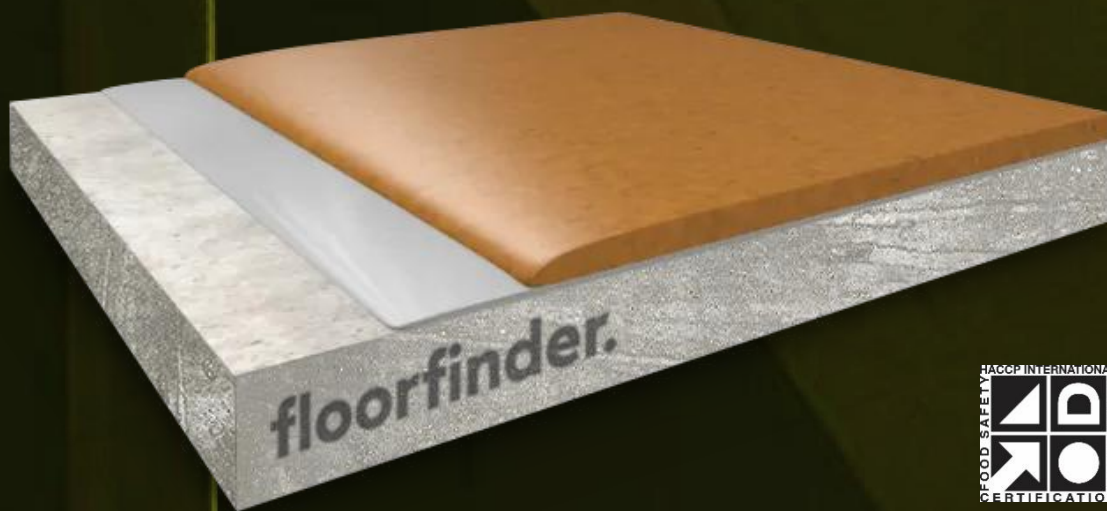
The final 3,000 sqm flooring system successfully addressed both the moisture challenge and the operational requirements of a confectionery facility.

- The moisture barrier and solvent-free epoxy primer ensured long-term adhesion and eliminated the risk of osmotic blistering.
- The PU-MF finish delivered a hygienic, durable, and chemically resistant floor suitable for heavy-duty food production.
- The adapted wall solution resolved plastering weaknesses, maintaining coving integrity without structural damage.
